# METEOROID AND DEBRIS IMPACT FEATURES DOCUMENTED ON THE LONG DURATION EXPOSURE FACILITY

## A Preliminary Report

Compiled by Members  
of the LDEF Meteoroid  
and Debris Special  
Investigation Group

August 1990

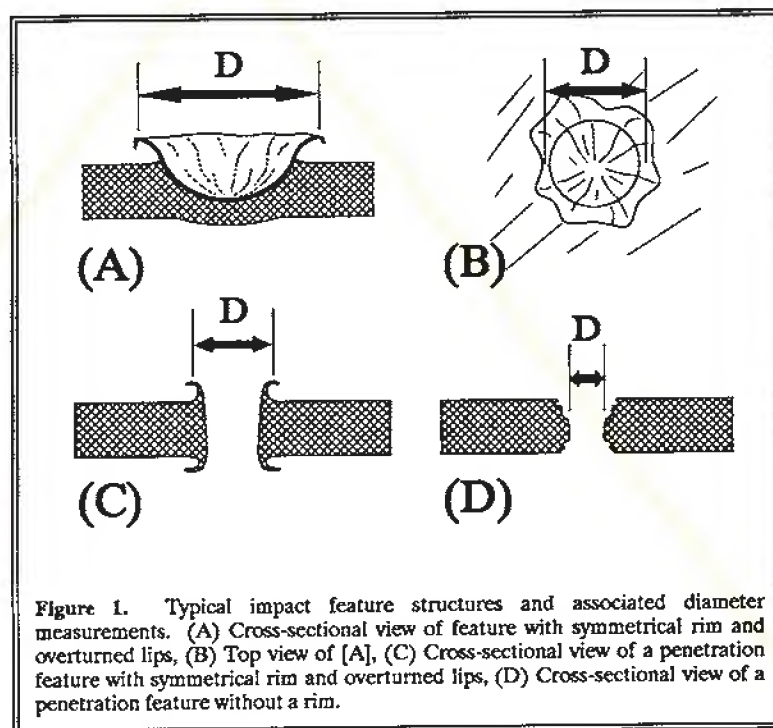
Figure 1. Typical impact feature structures and associated diameter measurements. (A) Cross-sectional view of feature with symmetrical rim and overturned lips, (B) Top view of [A], (C) Cross-sectional view of a penetration feature with symmetrical rim and overturned lips, (D) Cross-sectional view of a penetration feature without a rim.

Penetration-hole diameters were measured from edge to edge when rims were not present as illustrated in Figure 1d. When rims were present and symmetrical, the distance between the centers of opposing rims was taken as the feature's diameter (Figure 1c). When rims were asymmetric, either as the result of an oblique impact, or more commonly, the result of the collapse of "molten" material, a case by case determination of the apparent hole diameter was made. This was done by examining the feature under the SMIS and determining the position of the hole edge beneath the collapsed rim (Figure 4). Since this situation usually occurred on thin polymeric surfaces, such as the Teflon thermal blankets of the A0178 experiment, the collapsed rim was somewhat translucent and an adequate view of the inside hole edges could be obtained.

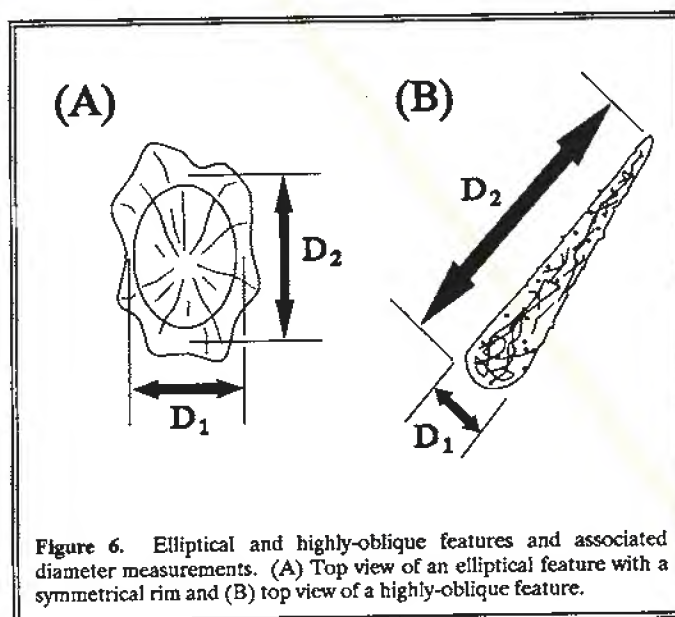
Elliptical features which had major- and minor axes which varied by  $\geq 10\%$ , and highly-oblique features (comet-shaped features whose lengths were several times greater than their maximum widths; Figures 5 and 6) are reported with the length of both axes indicated (e.g.,  $\sim 0.7 \times 0.9$  mm and  $\sim 0.4 \times 1.3$  mm). The limitations of the diameter measurement procedure in determining if features were elliptical in each type of surface were discussed above. Asymmetric rim formation was the major factor complicating diameter measurements. Accurate measurement of oblique-feature dimensions was often complicated by the poorly defined boundaries of the impact-affected area. The comet-shaped features usually exhibited clearly defined "heads" and more diffuse, or less well defined "tails". These were often composed of a series of microcraters which diminished in size and number with distance from the head to tail center line. The dimensions for such features were measured between the furthest points of altered surface material discernable under optical magnification.

Figure 6. Elliptical and highly-oblique features and associated diameter measurements. (A) Top view of an elliptical feature with a symmetrical rim and (B) top view of a highly-oblique feature.

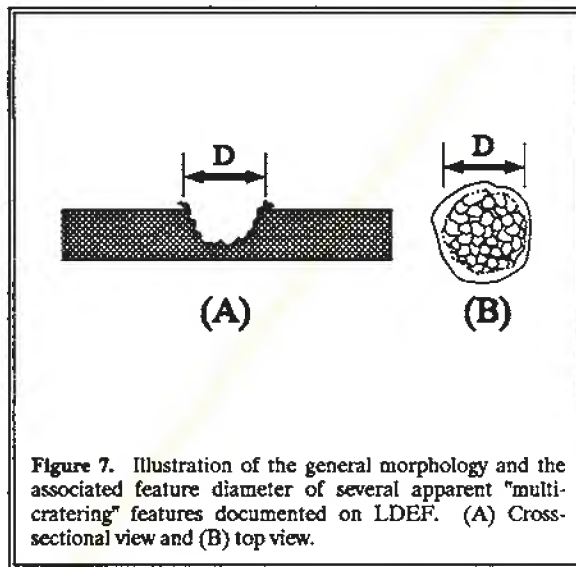
A few clearly identifiable multi-cratering events were found on metal surfaces. These unusual and rare impact features (Figure 7) consisted of tens to hundreds of smaller, well-formed craters lining the bottom, sides, and rims of the host crater formed by the overall impact. The diameter of the overall feature is reported in this paper, and comments describing the feature's morphology are included in the applicable summary reports.

Figure 7. Illustration of the general morphology and the associated feature diameter of several apparent "multi-cratering" features documented on LDEF. (A) Cross-sectional view and (B) top view.

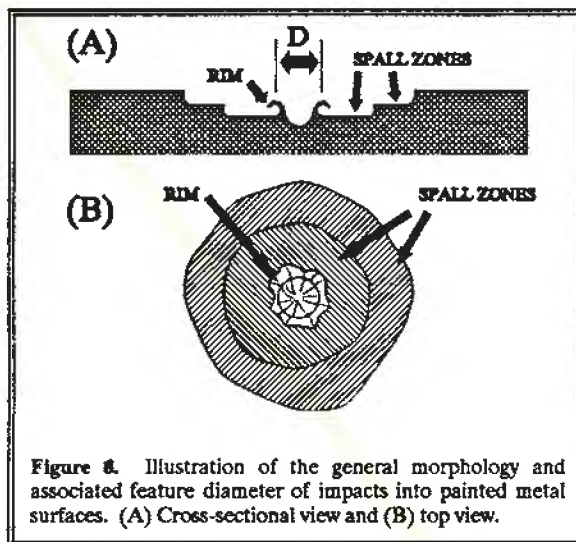
Craters  $>0.5$  mm in diameter on painted metal surfaces commonly possessed associated spall zones in the paint layers which extended for several crater diameters around the feature (Figures 8 and 9). On thin aluminum panels which were coated with several layers of paint there were frequently large, front-surface delamination zones extending tens of crater diameters around the impact sites. In many cases, diameters for these zones were measured and recorded in the comments field of the digitized image files.

Figure 8. Illustration of the general morphology and associated feature diameter of impacts into painted metal surfaces. (A) Cross-sectional view and (B) top view.

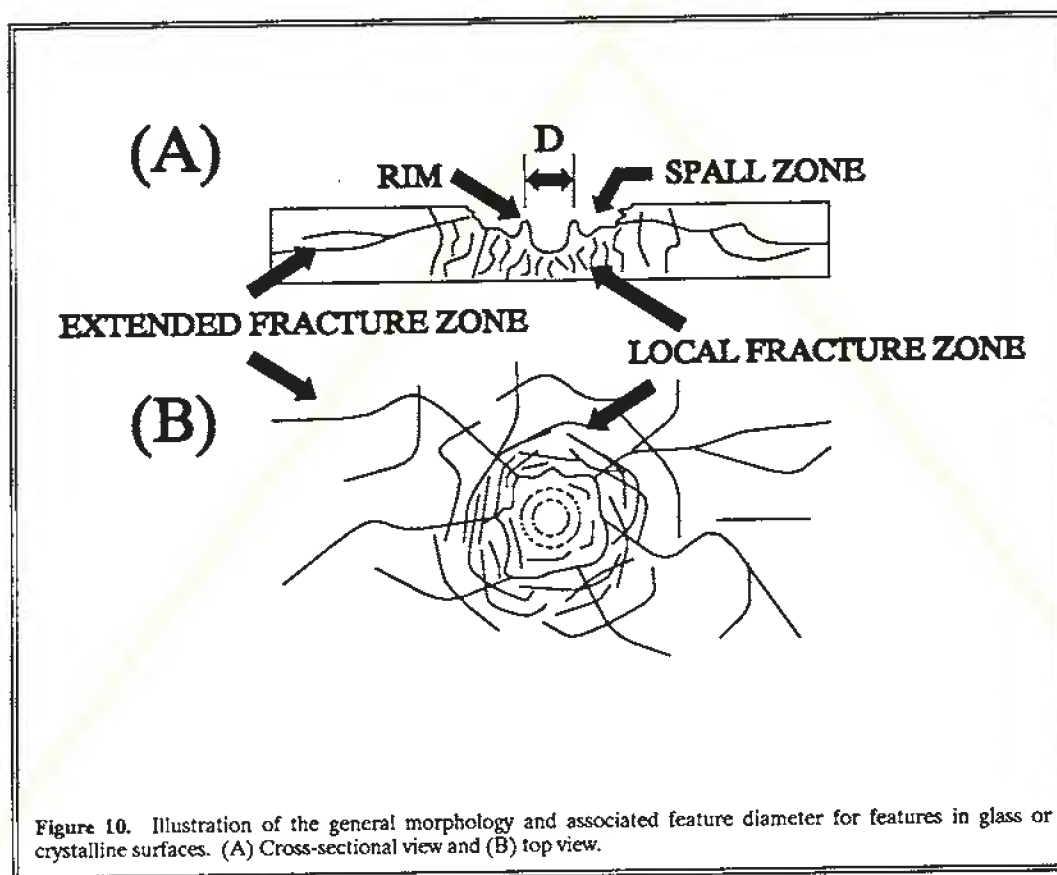
Figure 10. Illustration of the general morphology and associated feature diameter for features in glass or crystalline surfaces. (A) Cross-sectional view and (B) top view.

The extent of the spall and fracture zones, and the presence or absence of a rim around the central crater or penetration hole, were the major differences among impact features in glass and crystalline surfaces. When rims were present, or when there was a penetration hole without a rim, feature diameters were measured as depicted in Figures 1a and 1d, respectively. When rims were not present around a crater, the diameter of the residual crater was measured and reported (Figure 12).

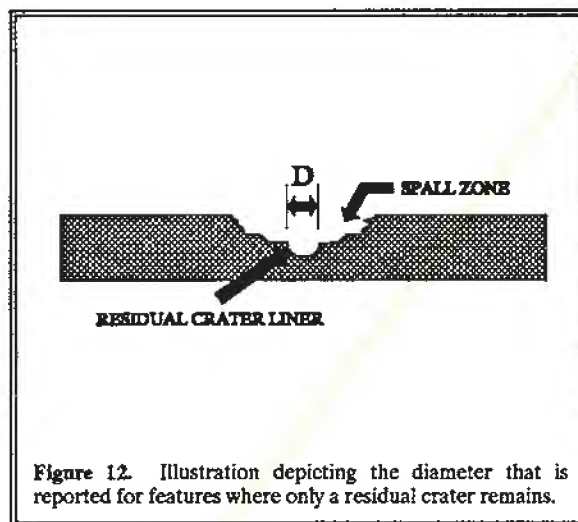
Figure 12. Illustration depicting the diameter that is reported for features where only a residual crater remains.

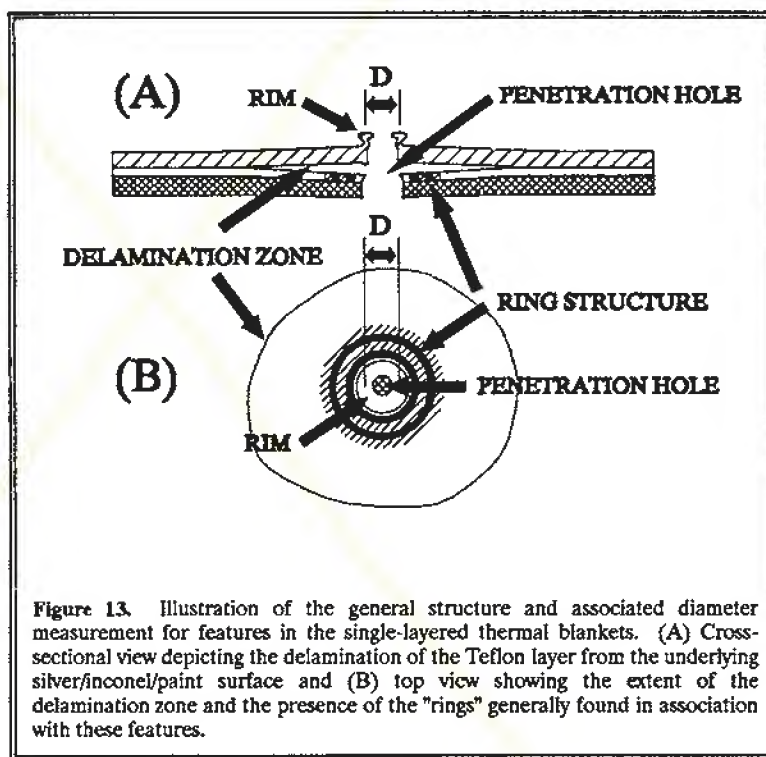
Figure 13. Illustration of the general structure and associated diameter measurement for features in the single-layered thermal blankets. (A) Cross-sectional view depicting the delamination of the Teflon layer from the underlying silver/inconel/paint surface and (B) top view showing the extent of the delamination zone and the presence of the "rings" generally found in association with these features.

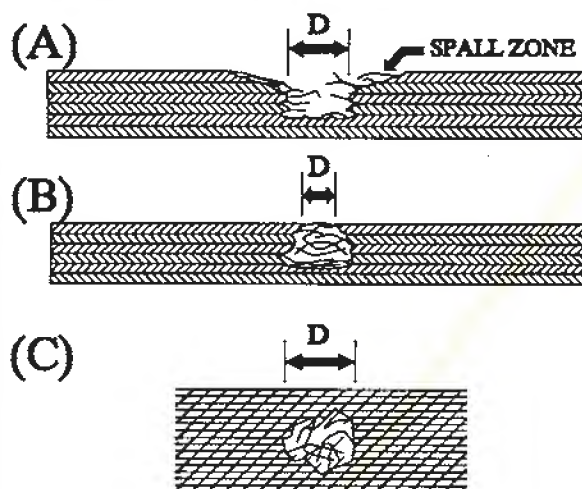
like the rimless hole or crater pictured in Figure 15a. Impact-induced damage of these structures generally took the form of broken fibers with missing binder material from the affected volume. Remnant fibers often could be found extending over the area of missing or excavated binder material, complicating feature location and diameter measurements. In some cases the diameter of the affected volume increased with depth. This effect appeared to be a function of the composites' density, layering technique, layer spacing, and fiber type. Feature diameters were always measured at the surface, as depicted in Figure 15.

Figure 15. Illustration of the general feature morphology and associated feature diameter for features residing in composite structures. (A) Cross-sectional view of feature with surrounding spall zone, (B) feature with a larger damage zone, beneath the composite surface, than is visually seen at the original material surface, and (C) top view of a feature in a composite surface. Note the overlapping of the entrance hole by fibers of the composite material.

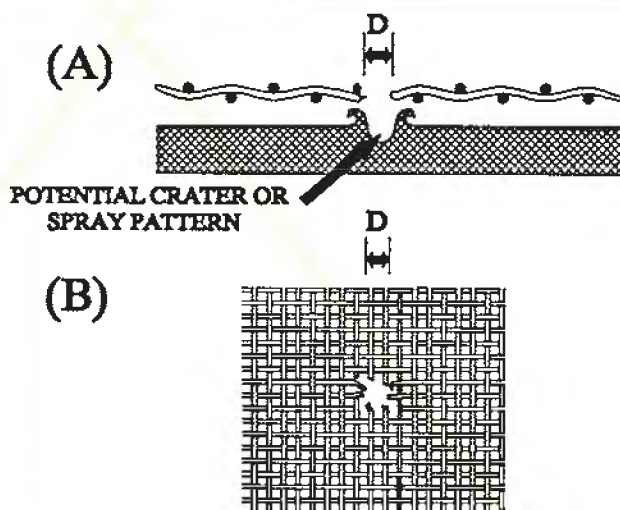
Figure 16. Illustration of the general morphology and associated diameter of features documented within fiberglass beta-cloth materials. (A) Cross-sectional view with potential crater or spray pattern underneath the beta-cloth layer and (B) top view.

frayed and pliable edges of the fibers around the impact site generally overlapped the penetration hole (Figures 16a and 16b), and it was not possible to see below the beta-cloth layer of this type of MTB. In addition, as a result of the few-hundred-micron yarn diameter and weave spacing, it was difficult to visually detect very small impacts into these beta-cloth surfaces. All penetrations which were detected in the beta-cloth surfaces (minimum size ~0.2 mm) were imaged. Feature diameters were measured from the apparent edges of the disrupted fibers on opposite sides of the hole.

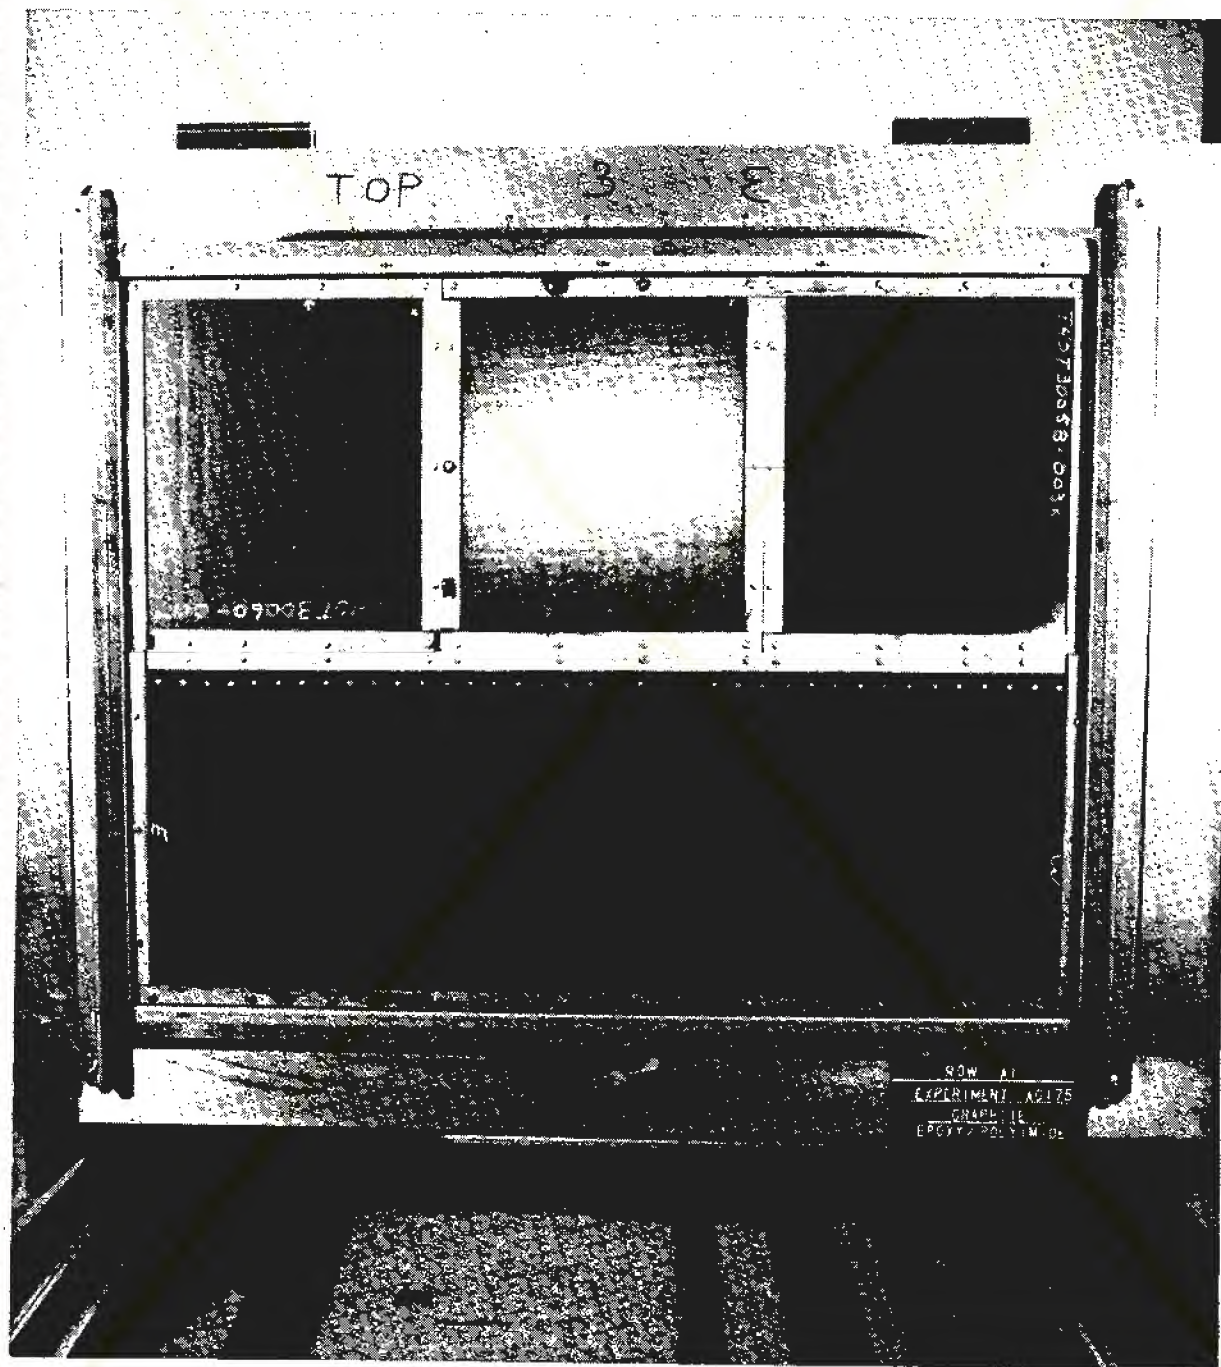
Figure A01-1. This post-deintegration view shows the front of the entire A01 experiment tray.

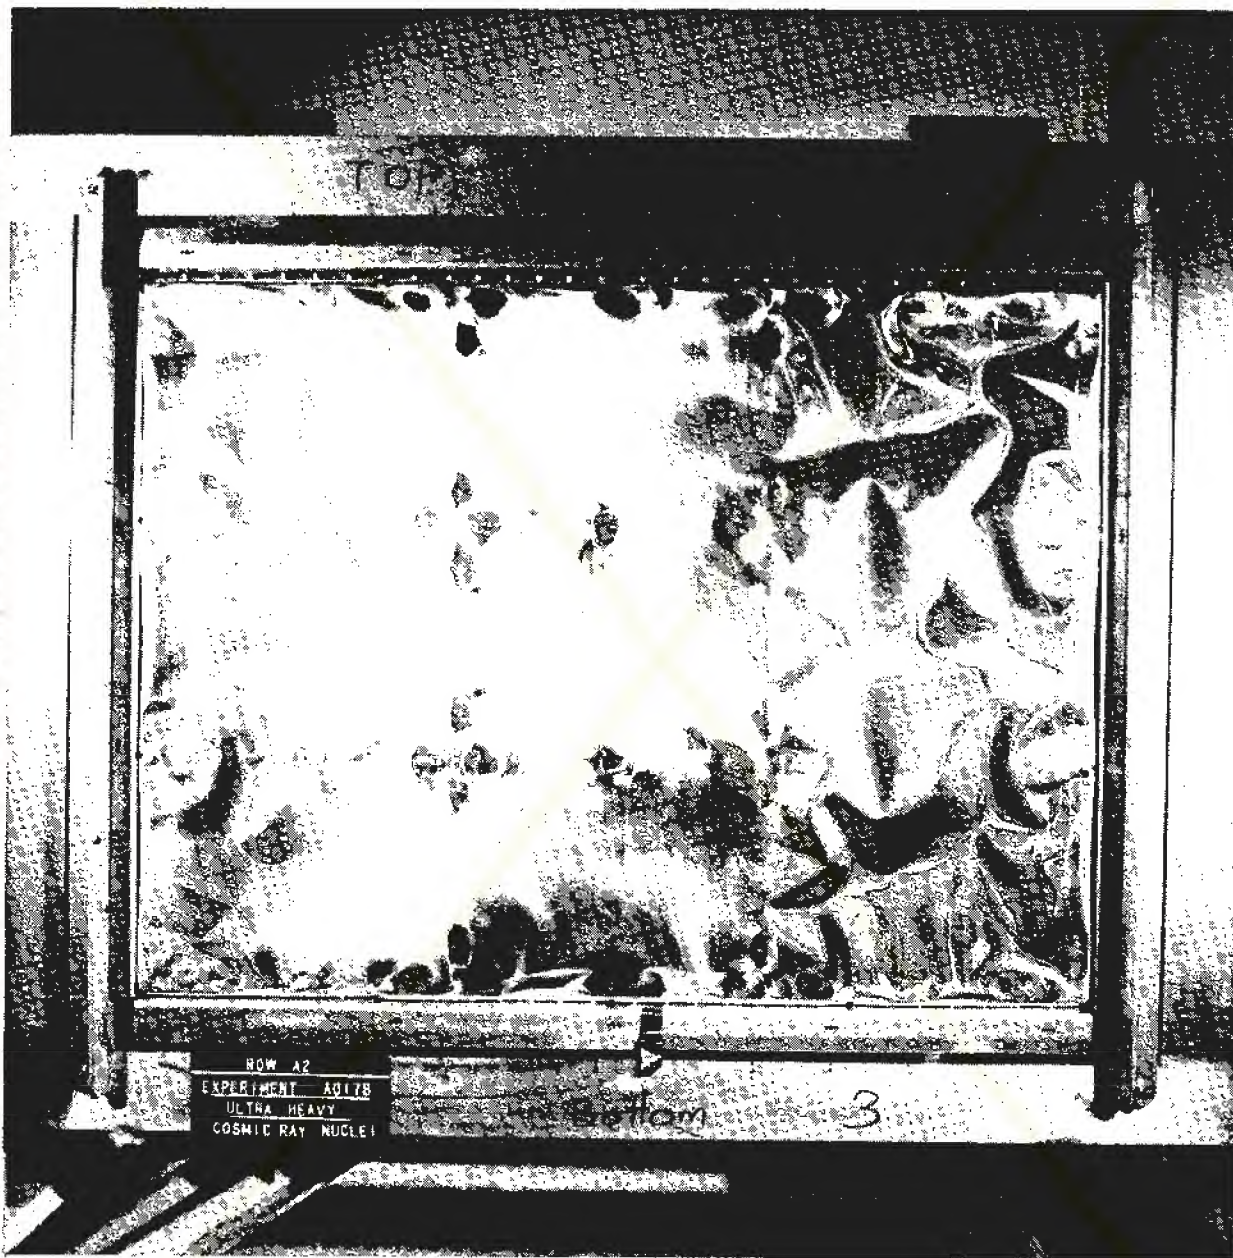
Figure A02-1. This post-deintegration view shows the front of the entire A02 experiment thermal blanket. *Fleur-de-lis* patterns across the blanket are surface expressions of the velcro attachment points to the underlying aluminum frame.

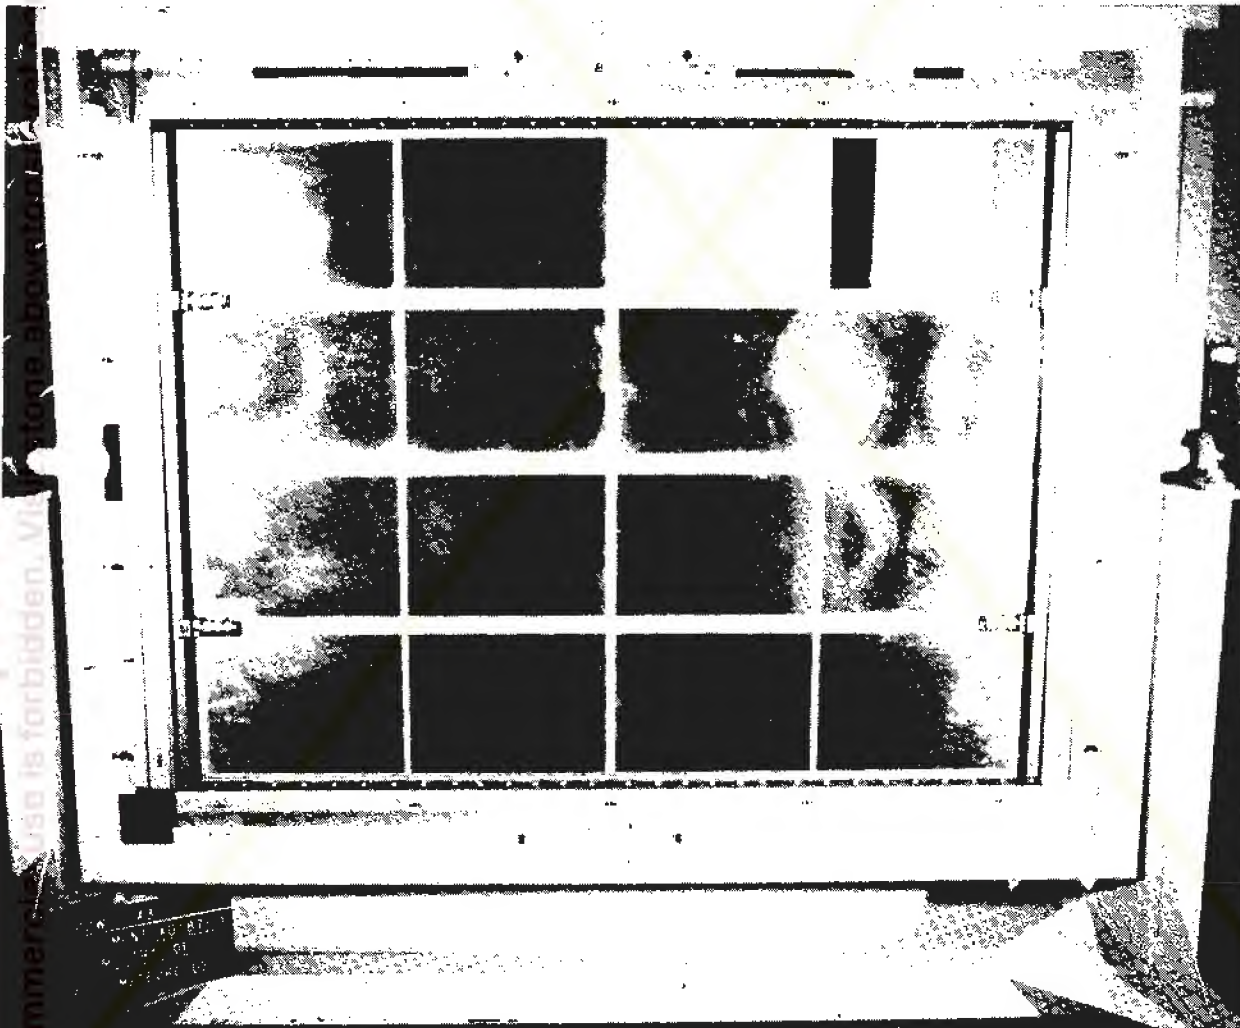
Figure A03-1. This post-deintegration view shows the front of the entire A03 experiment tray, showing the two aluminum base-plates.

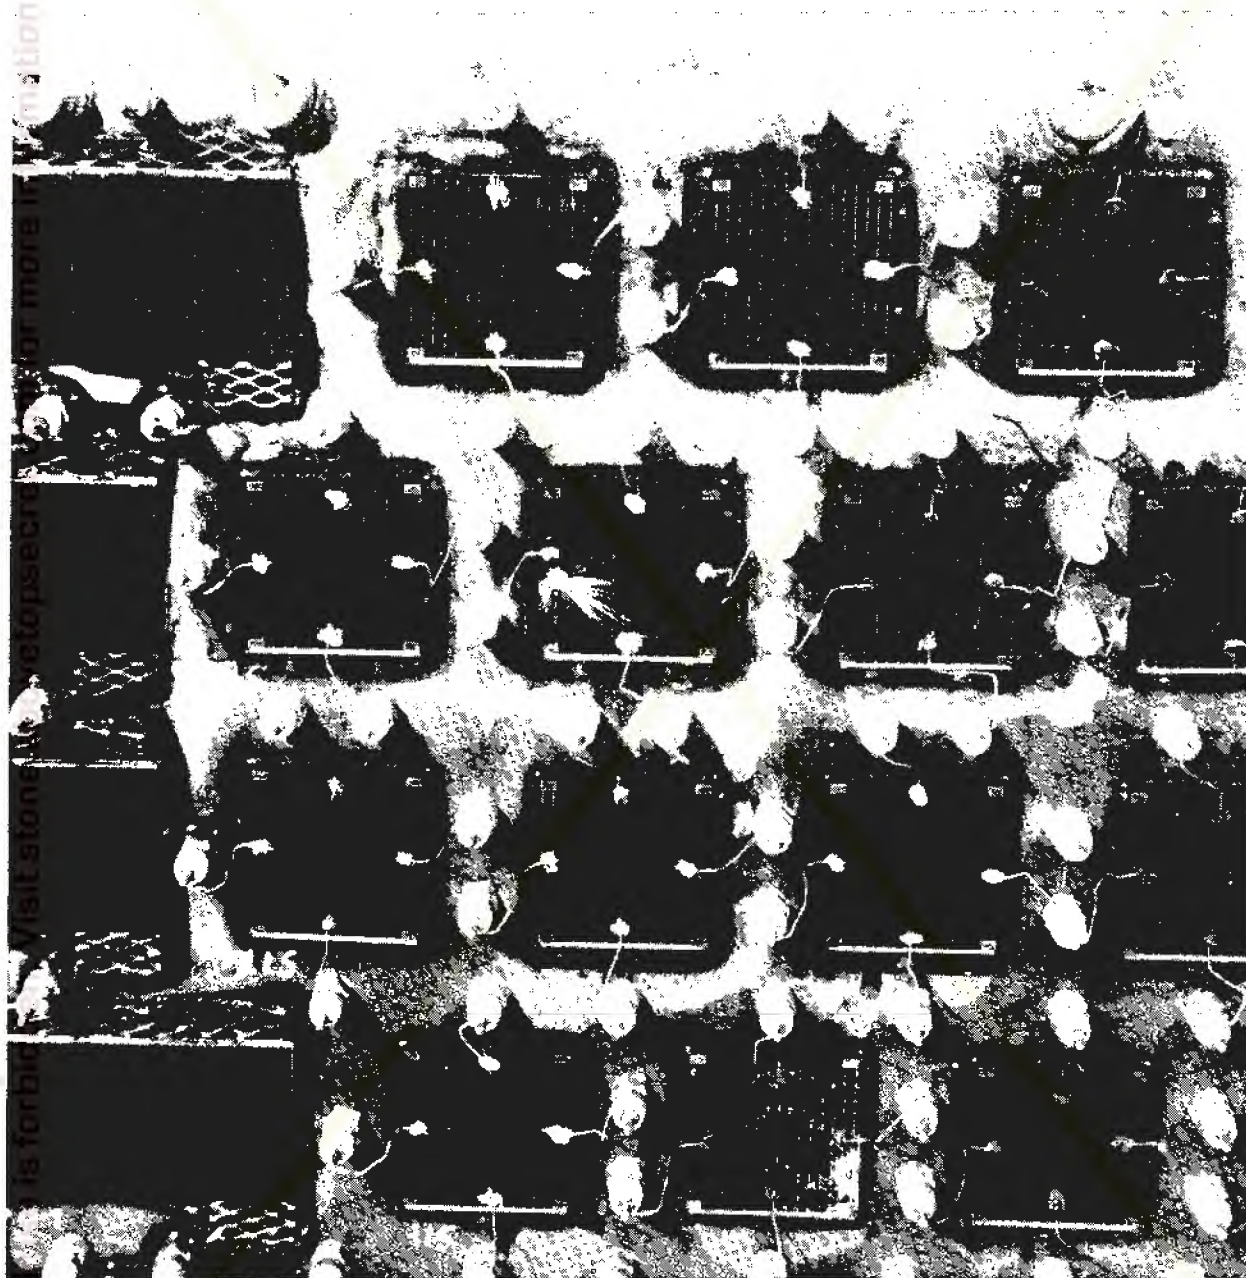
**Figure A08-3.** This is a close-up on an impact into a solar cell, showing accompanying shattering, and measures approximately 3 cm across.

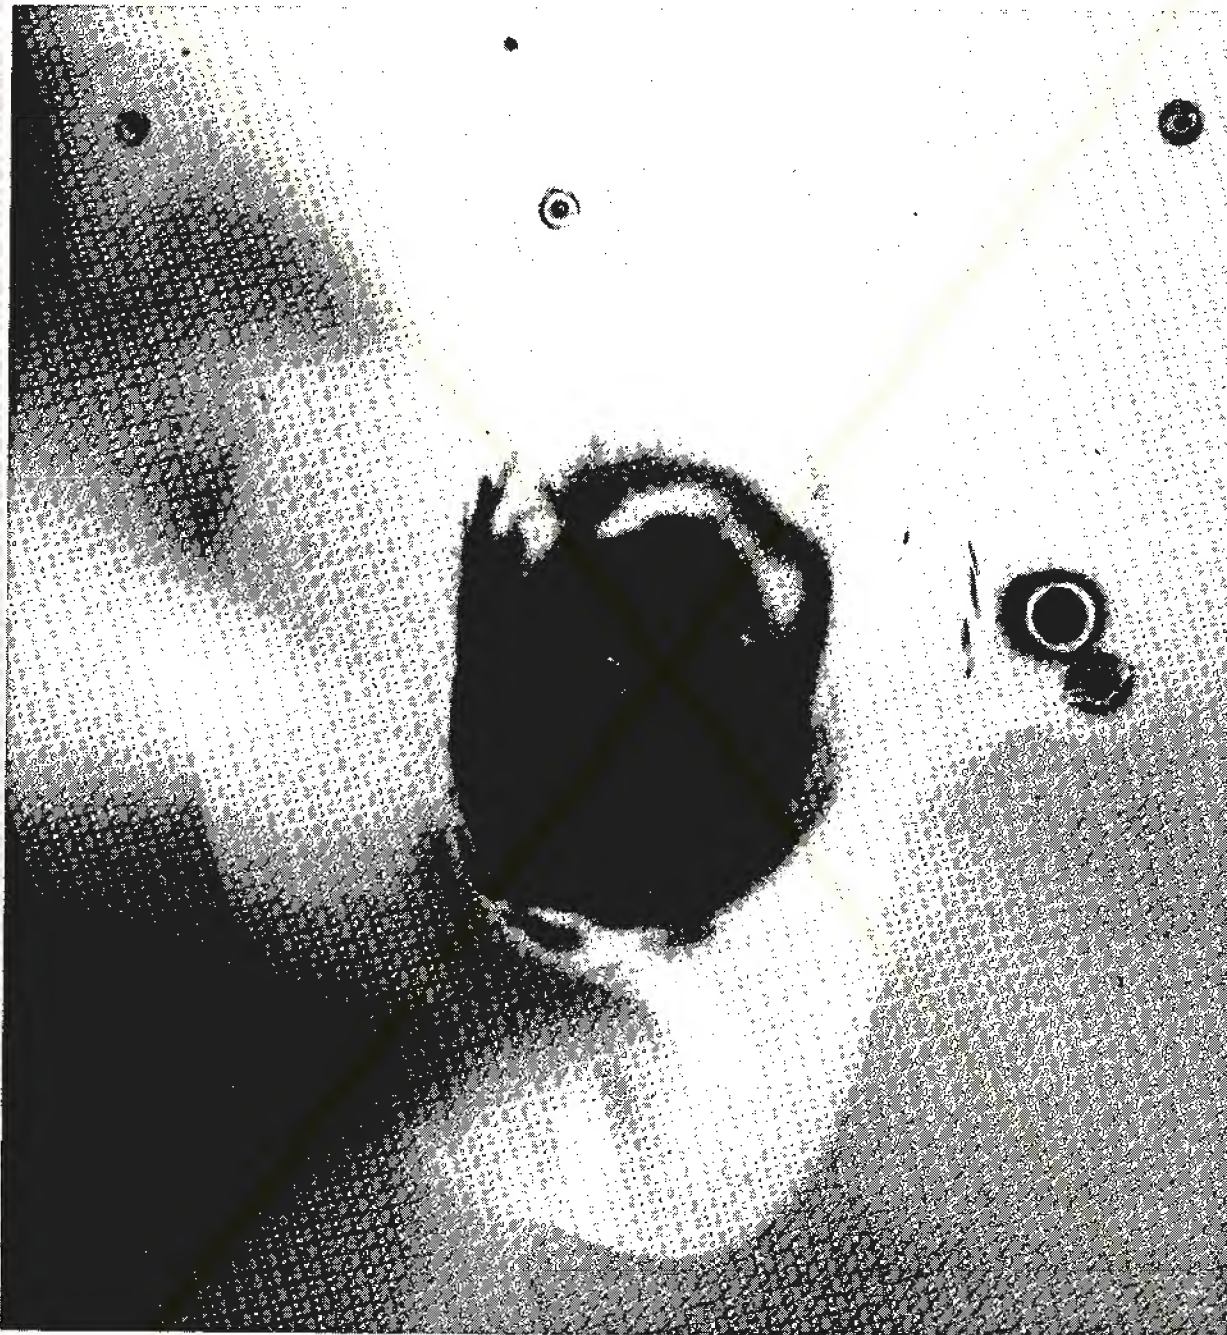
**Figure A10-2.** This is a view of large impact features on the A10 thermal blanket. Dark rings encircle many of the features. Some rings are incomplete. Rounded delamination areas surround most impact features shown here. View measures approximately 10 cm across.

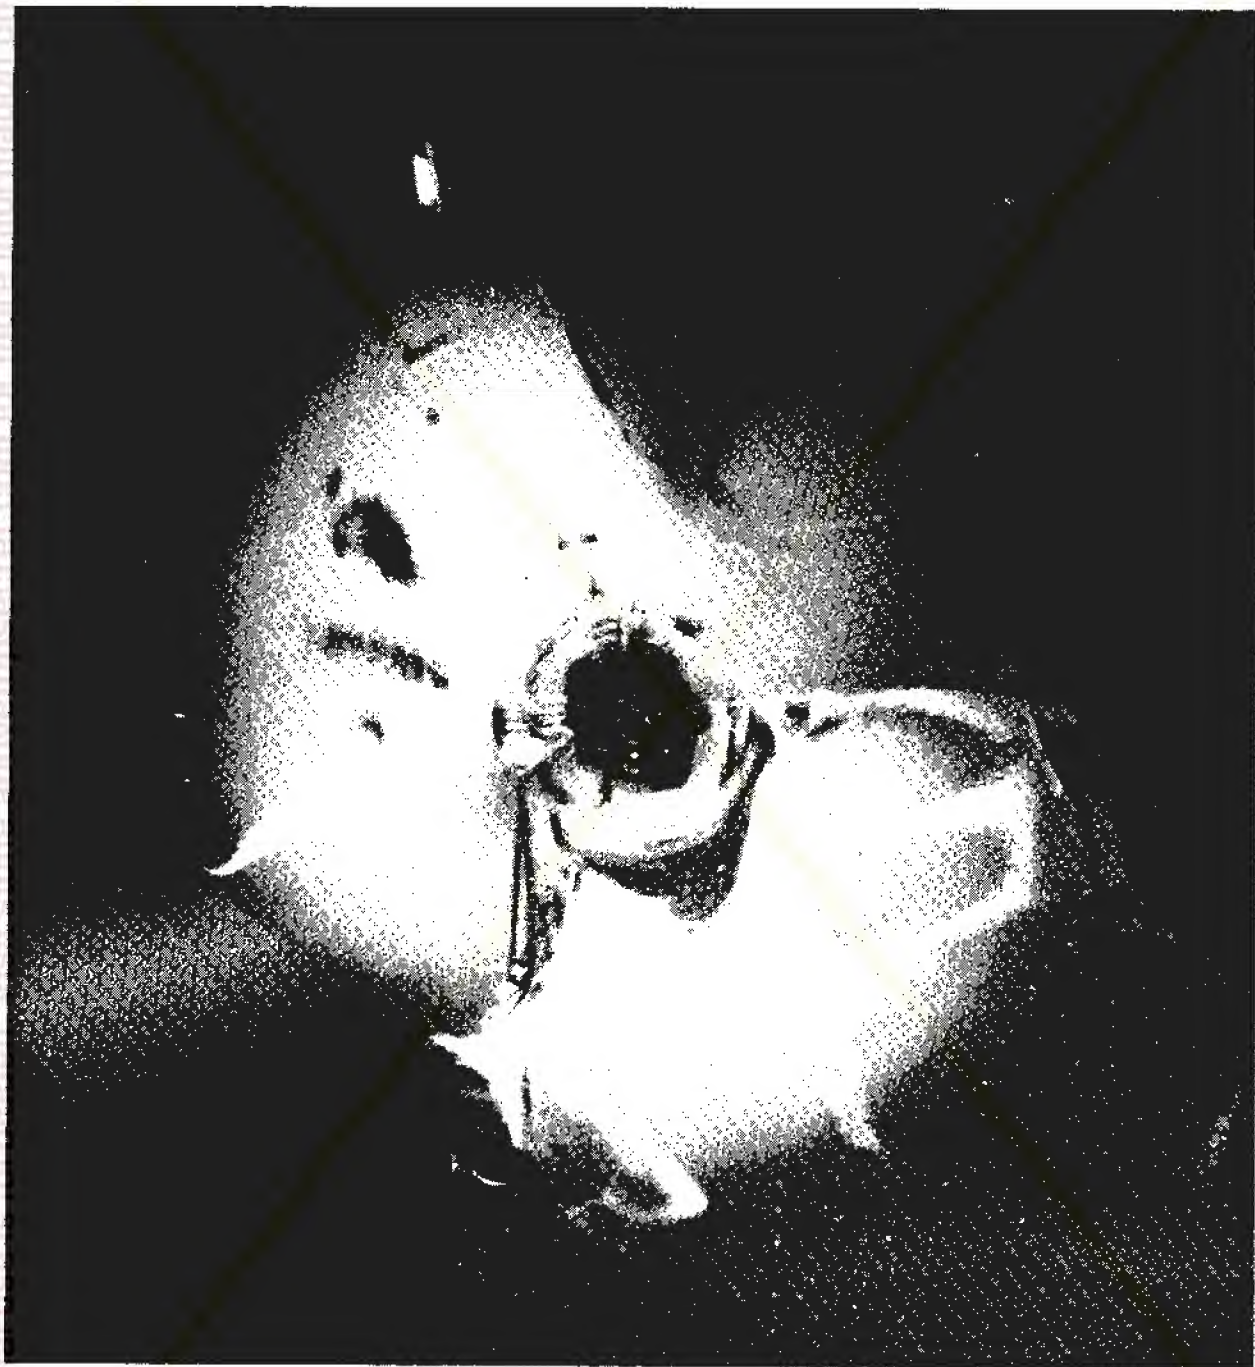
**Figure B07-1.** This is a view of one large impact feature on the B07 thermal blanket. A rounded delamination area surrounds the impact feature shown here, and the penetration hole is not spherical, possibly reflecting deformation of the Teflon surface. View measures approximately 10 cm across.

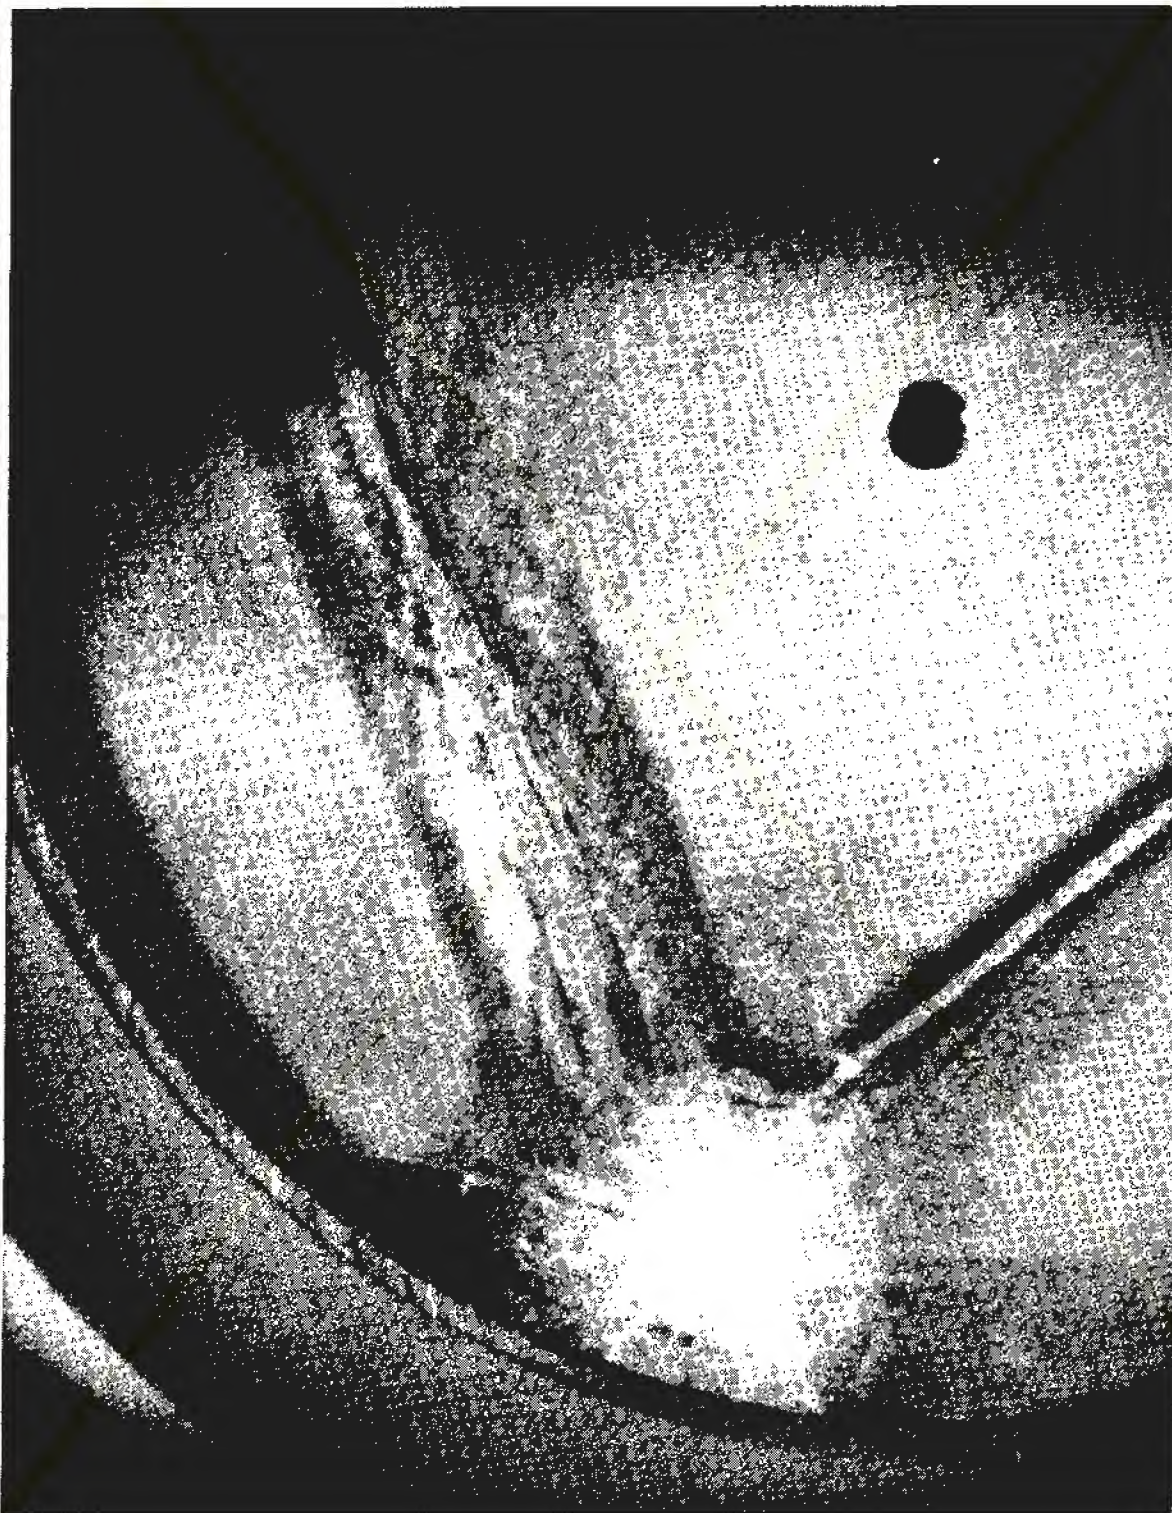
Figure B08-1. This is a view of one large impact feature on an optical surface from tray B08. Large radial cracks extend across the entire surface of the sample, and the "crater" consists of finely-shattered material. View measures approximately 2 cm across.

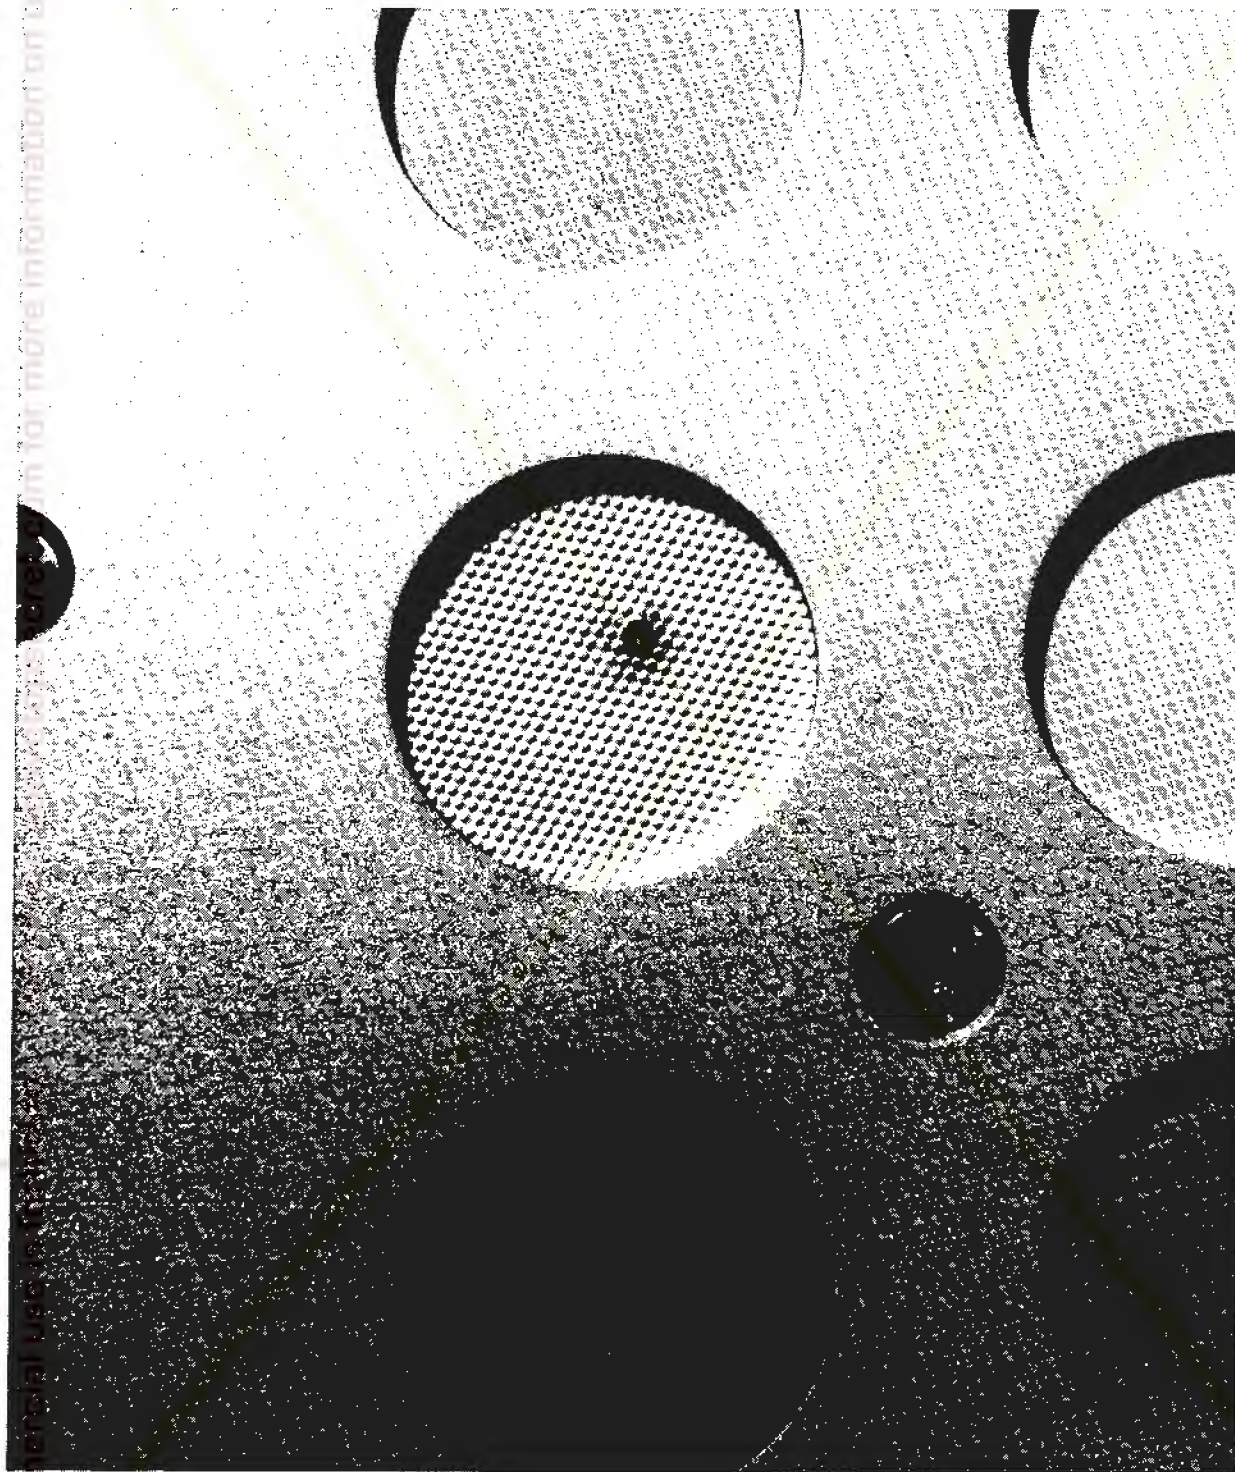
**Figure B09-3.** This view illustrates impact features in two materials from the bottom of Tray B09. View measures approximately 4 cm across.

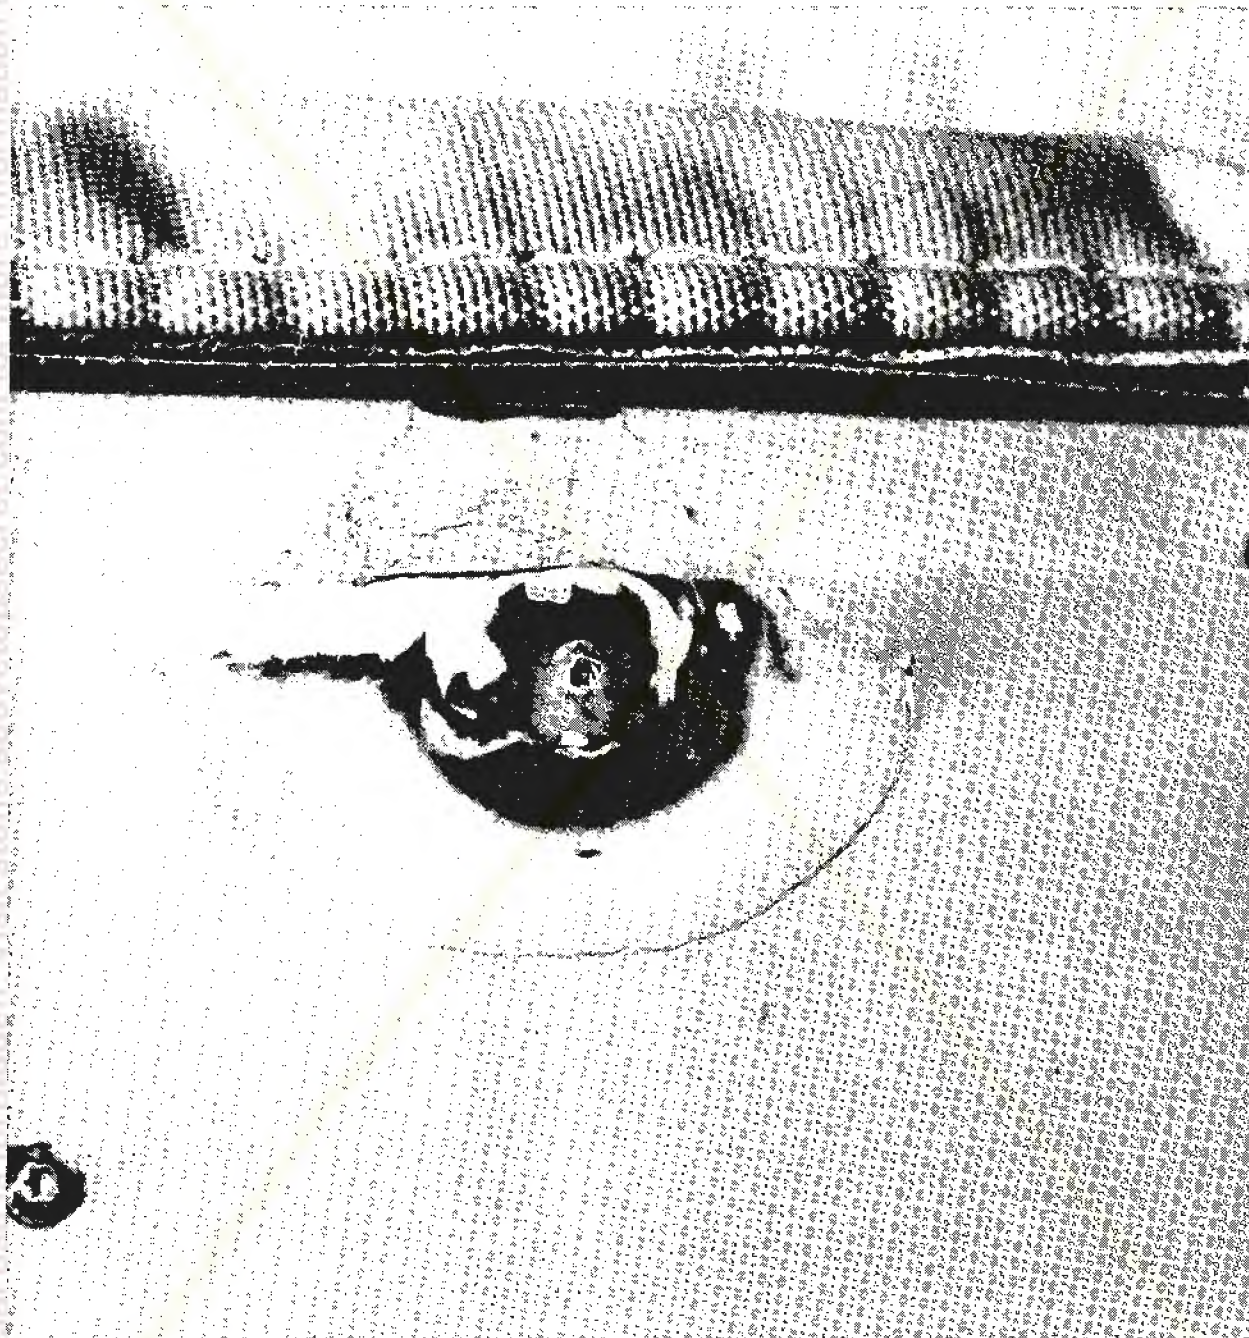
**Figure B10-2.** This is a view of a large impact with spall across one of the heat-pipe covers. View measures approximately 4 cm across.

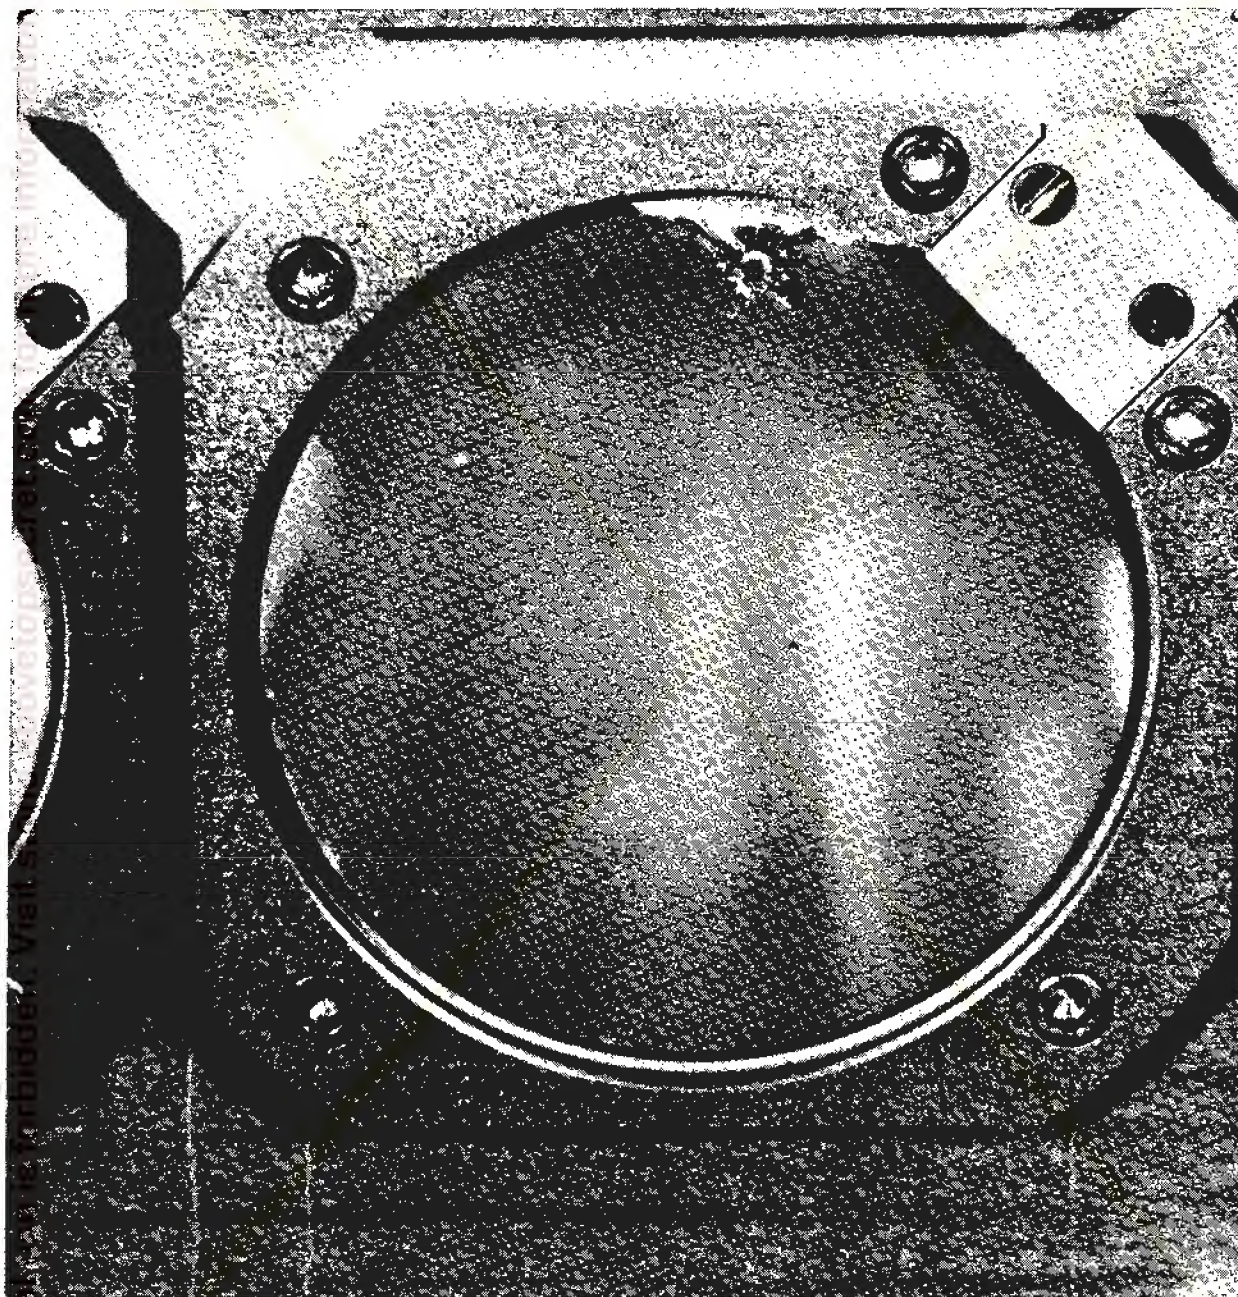
Figure B12-2. This is a view of impact feature #17, with associated shattering, onto a MOS detector. View measures approximately 9 cm across.
